5BV.2.34 Drone-Based Assessment of Cleaning Effects on PV Installations

EU PVSEC 2016, Munich, Germany, 20-24 June 2016
Manuel Lanz, PD Dr. Eva Schuepbach, Prof. Urs Muntwyler

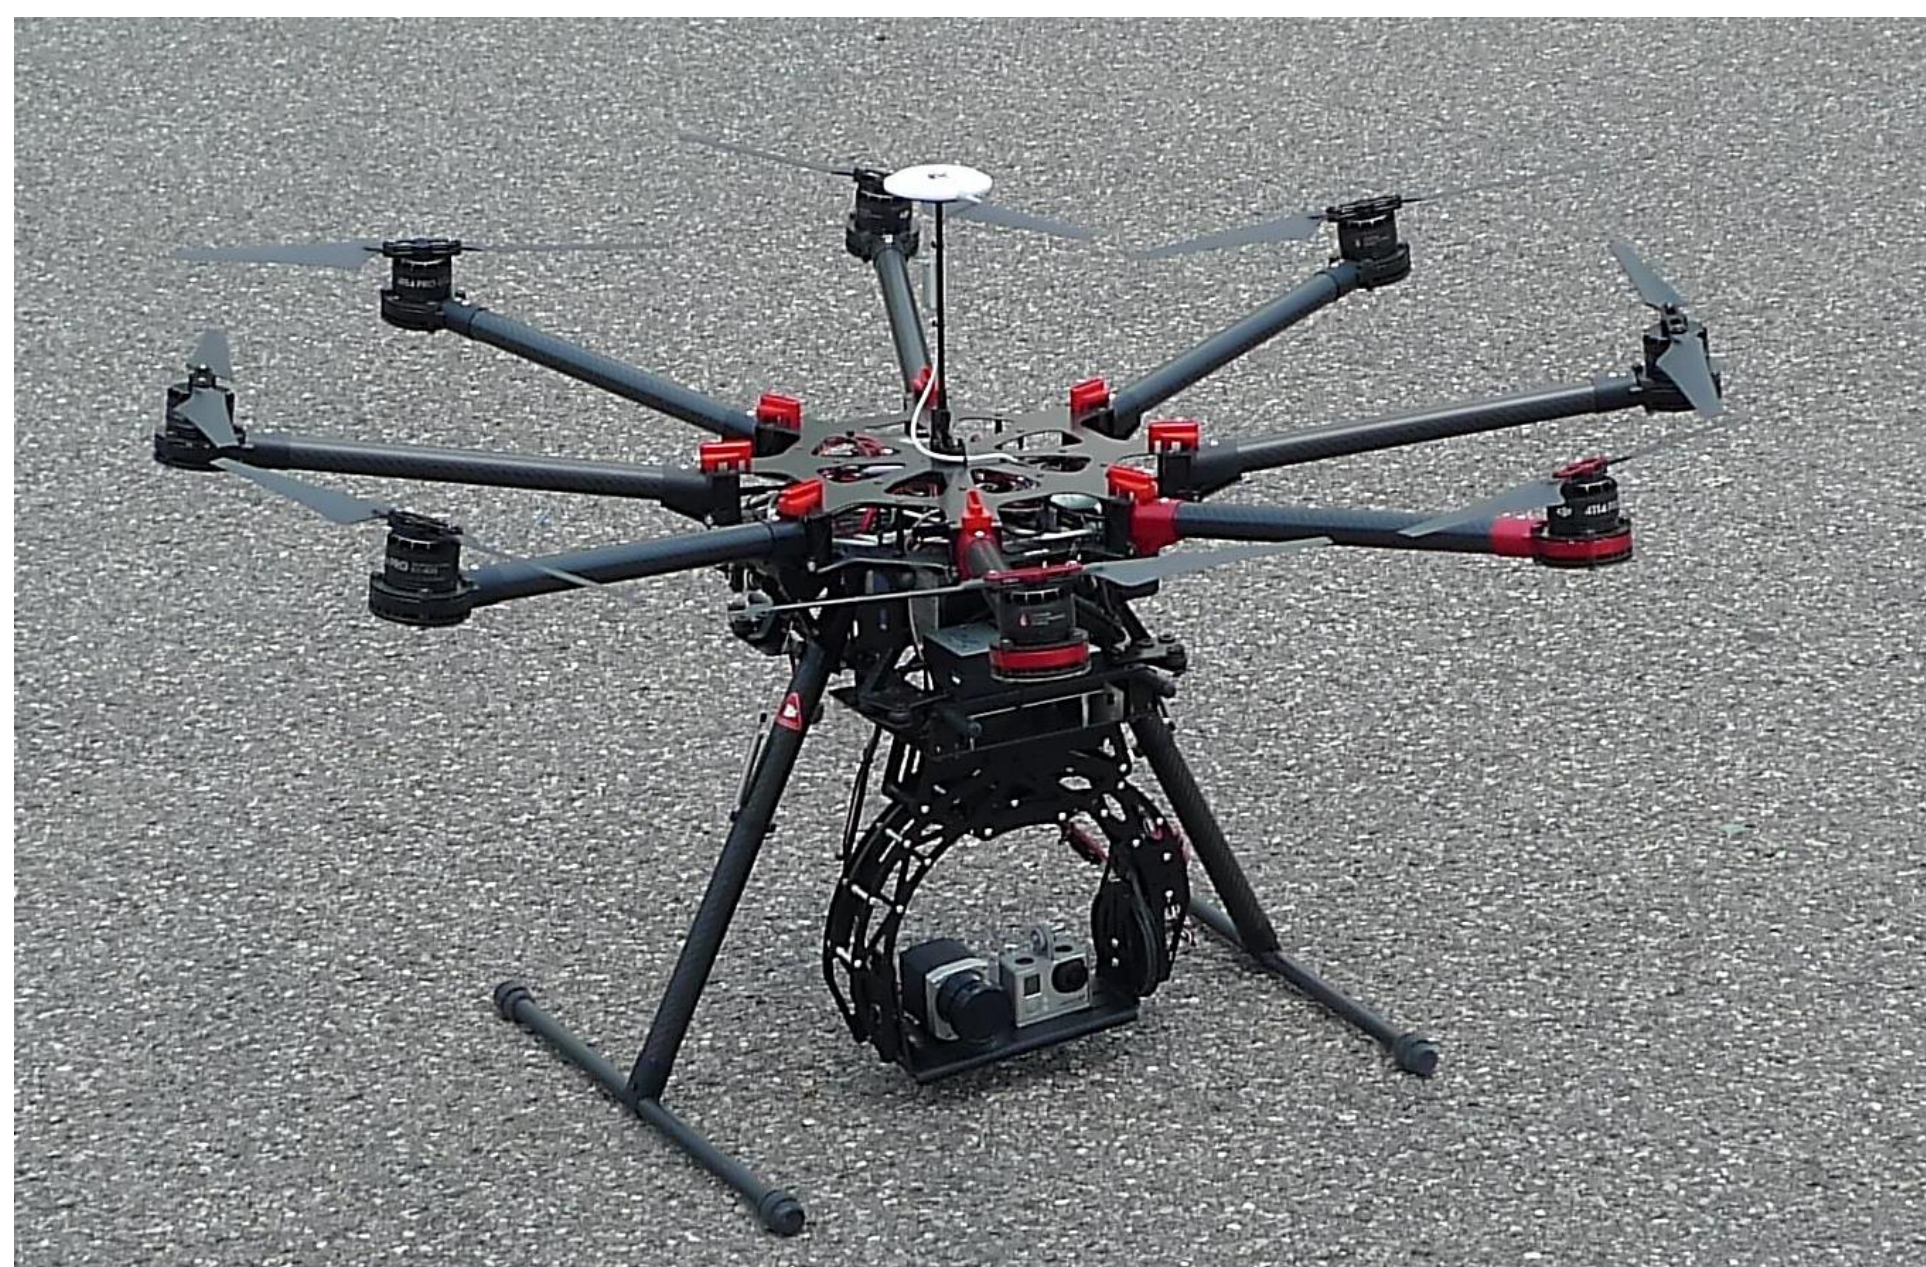
The PV LAB IR-multicopter drone (Fig. 1) carries an infrared camera that records a thermal imaging video and a digital camera for comparison shots. Using this combination, PV module surfaces can quickly be monitored and defects easily determined and located.

Fig. 1: PV LAB IR-multicopter drone; the take-off weight is about 7.5 kg.

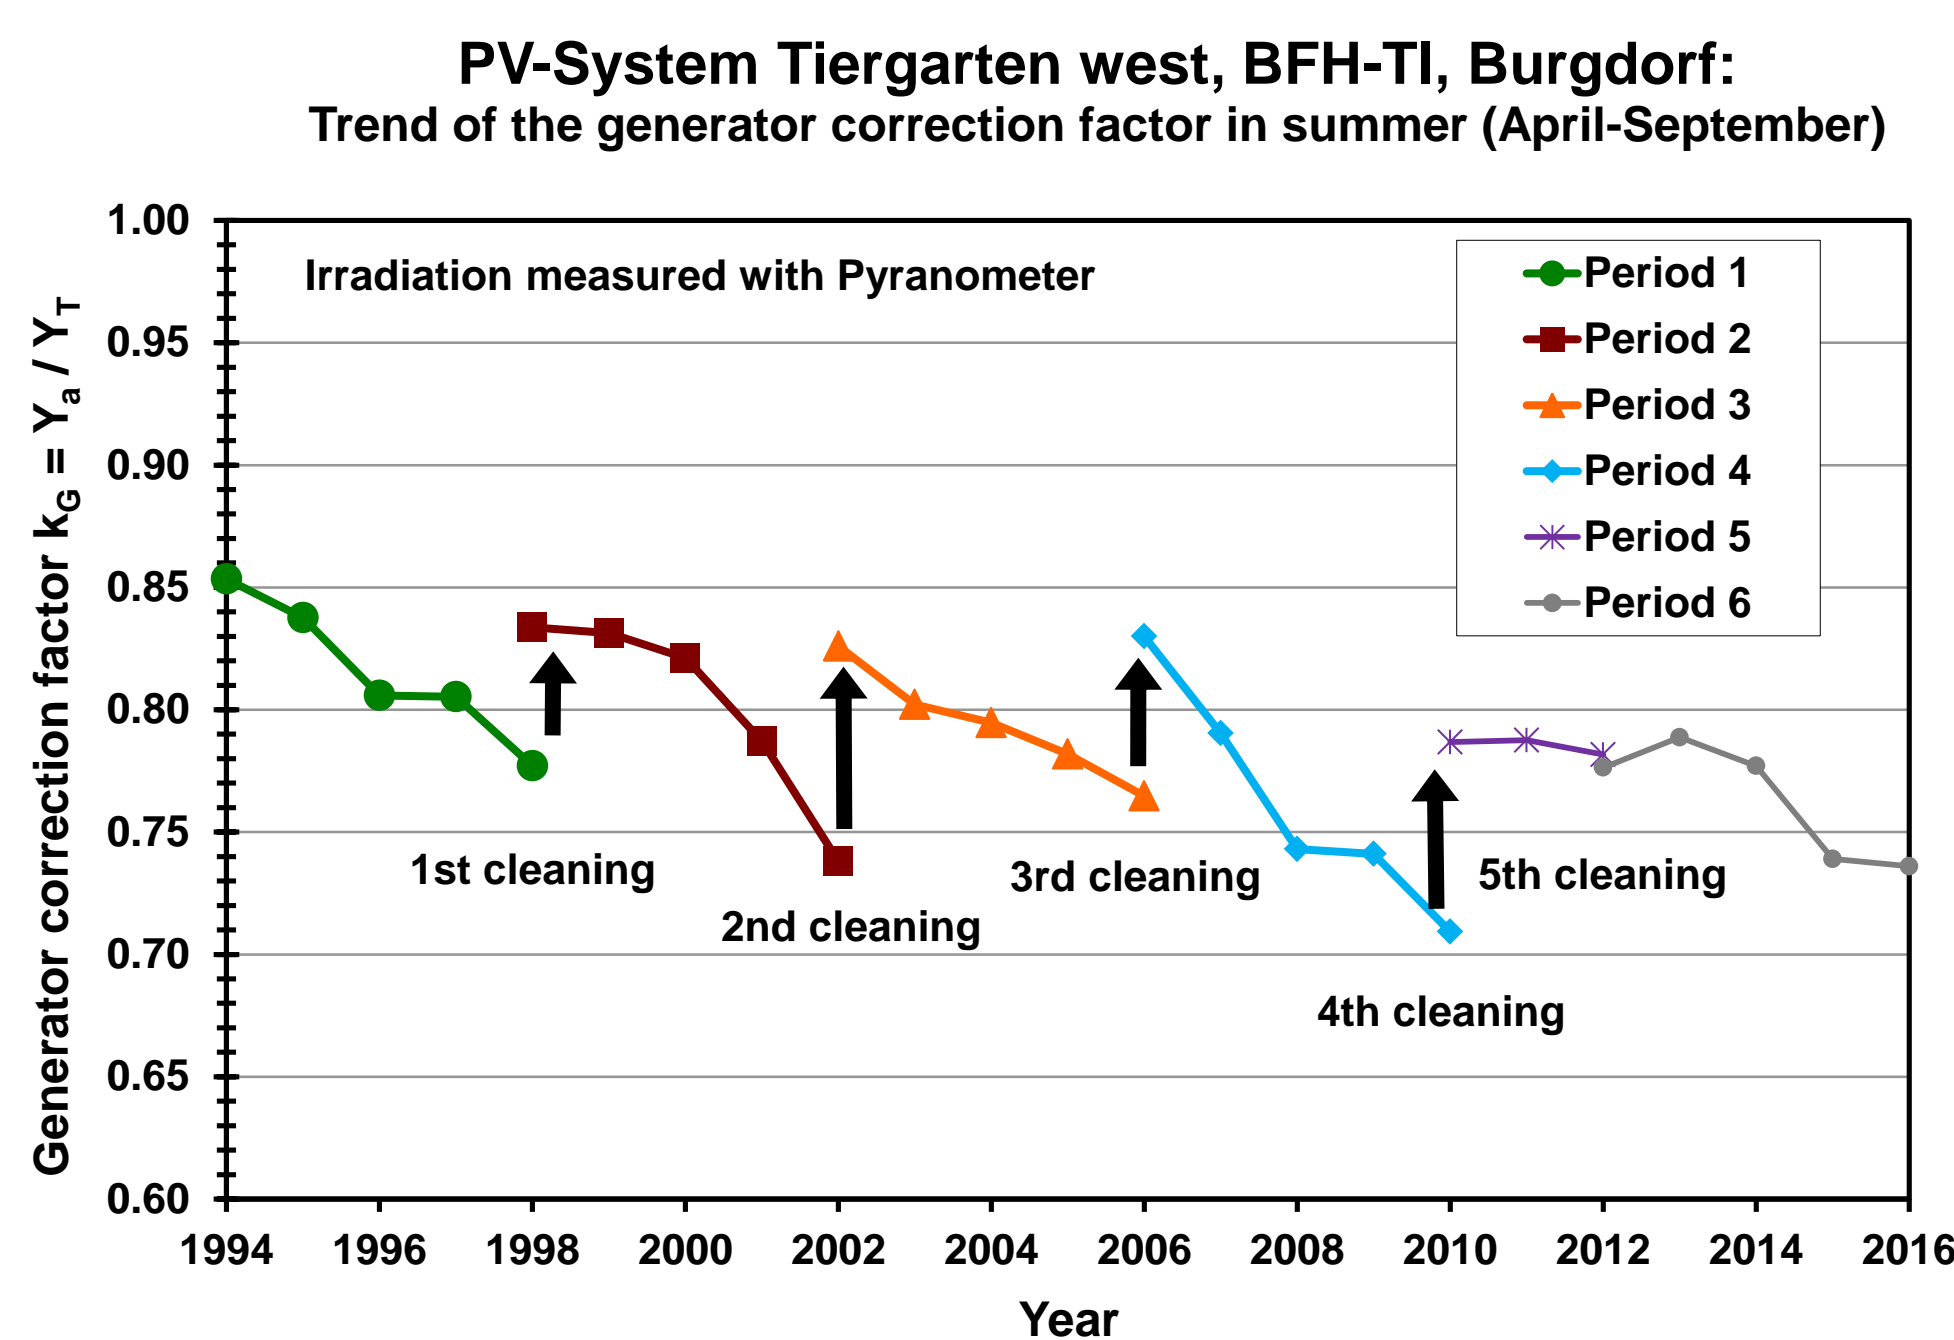
Regular cleaning of the PV module surfaces increases the electric energy output. Long-term effects of PV module surface cleaning are displayed in Fig. 4. The PV installation is a 50 kWp roof-top system cleaned every four years since the 1990s, resulting in a yield gain of 5-8%.

Fig. 4: Energy yield increase (1994-2016) of the PV installation at the PV LAB due to cleaning.

The values in Fig. 4 show the "generator correction factor" k_G , representing the ratio of the actual yield to the theoretical yield. k_G is formed by dividing the "array yield" (Y_A) by the "temperature-corrected radiation yield" (Y_T) in Formula 1.
