## **Arc Detector for Remote Detection of Dangerous Arcs on the DC Side of PV Plants**

**H. Haeblerlin**

**Markus Real**

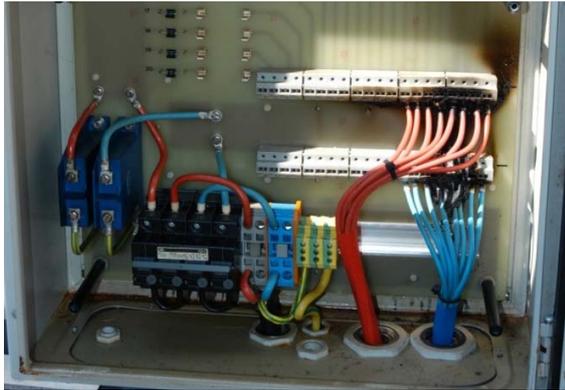
**Fig. 2:**

Damage caused by a smouldering fire, which occurred in the connector box of an 11 year old PV plant in Burgdorf. Fortunately this fire was in a metal cabinet that kept it confined.

In spring 2006, a smouldering fire occurred in the connector box of an 11 years old PV plant (15 kWp,  $U_{MPP-STC} \approx 590$  V) in Burgdorf that has been under analytical monitoring by the PV laboratory of BFH since 1995. According to the traces found, this smouldering fire was probably caused by a soldered joint that increased its resistance slowly in course of time. By means of the analytical monitoring data it could be seen that it probably finally melted during a cloud enhancement. The open soldering point then ended up in a DC arc that damaged the connectors soldered to the printed circuit board (see fig. 2 and 3). As there was a metal box (fortunately), the further access of oxygen was not possible, the smouldering fire extinguished after some time, but the affected string was out of order afterwards.

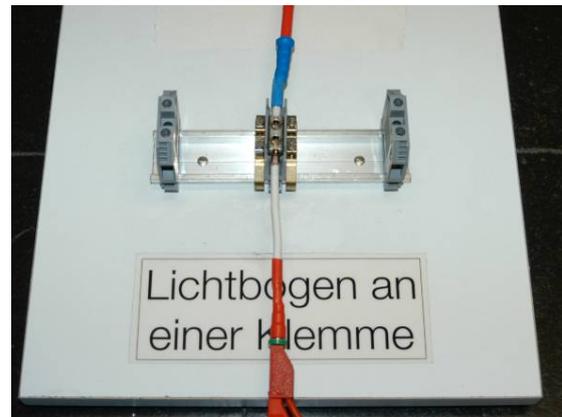
**Fig. 6:**

The positive lead of the cable (length about 50 m) between the PV array simulator on one side and the AD and the inverter at the other side is connected to a clamp immediately at the PV array simulator. If this clamp is loosened, dangerous arcs can occur (see fig. 7).

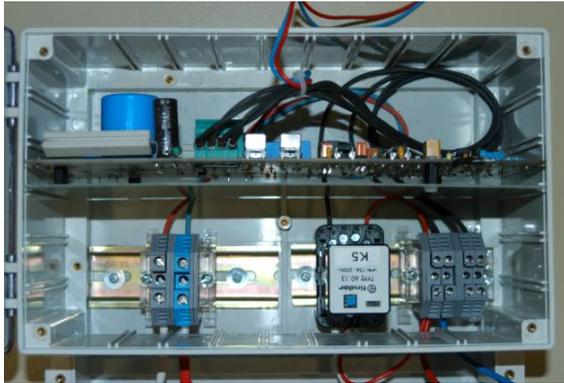
**Fig. 8:**

The arc detector (AD) with IDU which was used for these tests performed in autumn 2006 was composed of parts that were still available from earlier projects. For convenience, many parts were used that would not be needed for an AD integrated into an inverter. In this experimental setup, the electromechanical activation of the QDC switch is performed by means of auxiliary circuit and a relay shown in the lower part of the picture.
